Weathering and service life of anodized aluminium

Robin Furneaux, 3rd August 2011

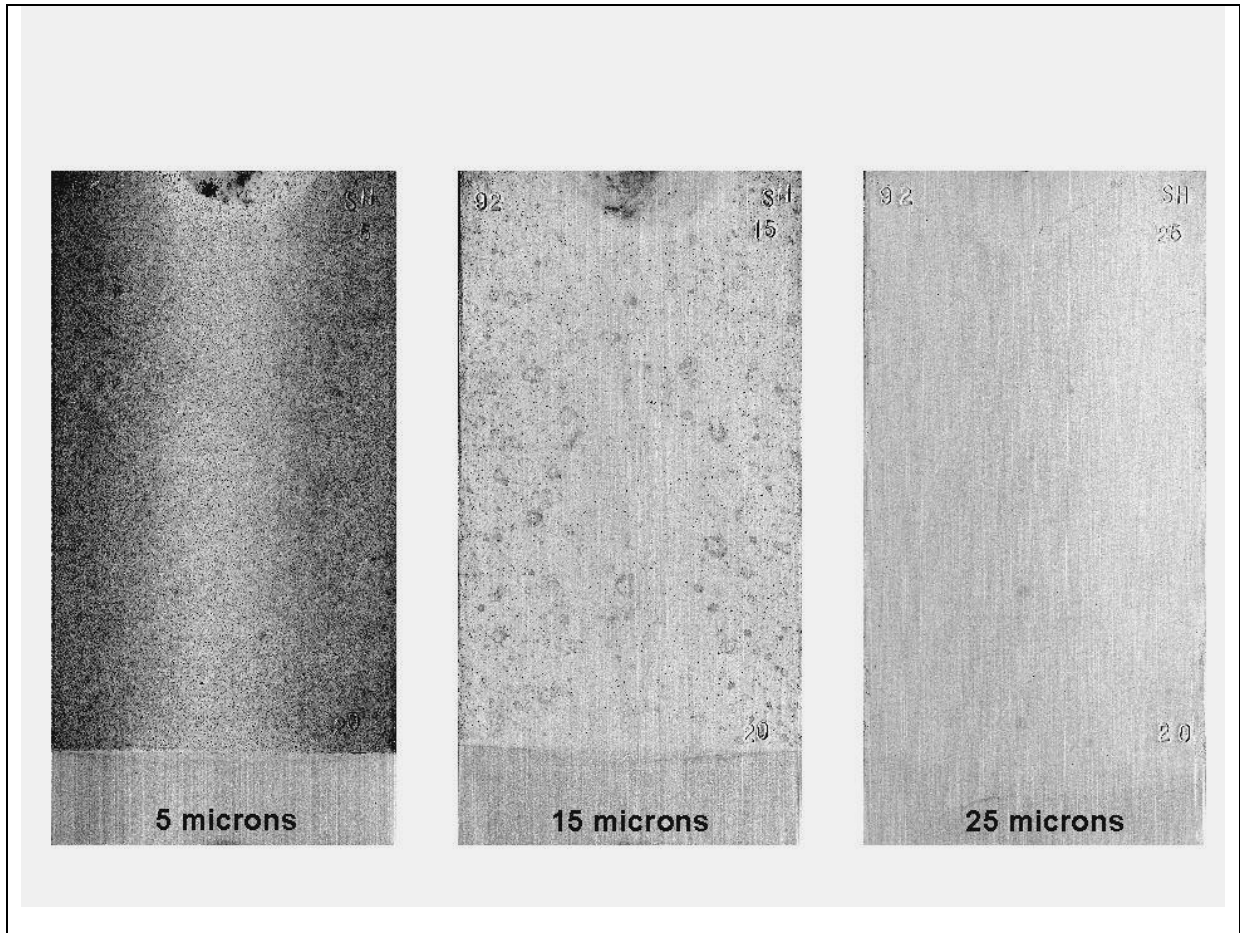
Figure 1 Anodized aluminium extruded panels (150 x 75 mm) originally with 5, 15 and 25 μ m coatings after weathering at Sheffield from 1979 to 1999 showing the extent of pitting attack (R.C.Furneaux, ATB Metallurgie, 43, 84 (2003))

The anodic coating protects the aluminium substrate against pitting corrosion which manifests itself as localized dissolution of the metal. Note that although pits might be visible, they remain small and do not significantly propagate, which is why structural failure does not occur. Aggressive chemicals from the environment have to reach the metal surface before pitting can commence. This requires the dissolution or penetration of the anodic coating at each site of a pit. The degree of protection provided by the anodic coating on anodized aluminium in a given environment depends primarily on the coating thickness. It is largely independent of sealing quality. Good quality anodized aluminium will lose coating thickness progressively over time and, eventually, pitting corrosion will take place. Of course, any assessment of how much pitting is unacceptable is subjective depending on the expectations of the observer (Figure 1).
